The Evaluation of the Coastal Protection Structure at Rangkan Beach, Gianyar Regency

ABSTRACT: Pantai Rangkan is one of the beaches that has been experiencing abrasion year after year, with a beach length of ± 485 meters. Pantai Rangkan has suffered significant damage in the form of shoreline retreat due to continuous wave impacts throughout the year, causing erosion and wave overtopping on revetment structures. In 2022, a tidal flood occurred, with overflow reaching the temple area and the surrounding rice fields. Along a stretch of ± 92 meters, there are revetment structures that have been covered by sedimentation, reducing the performance of these revetment structures. Based on these issues, an evaluation was carried out on the coastal protection structures at Pantai Rangkan. The results of the physical condition and performance evaluation of the revetment structures indicate that segments 1, 3, 4, and 5 need to be re-assessed with the current revetment crest elevation (+5.000 m), using wave transformation results with SMS 10.1 software by inputting HWL data (+2.659), H25 (4.057), T25 (6.762), and the dominant wind direction (southeast). The evaluation results for segments 1, 2

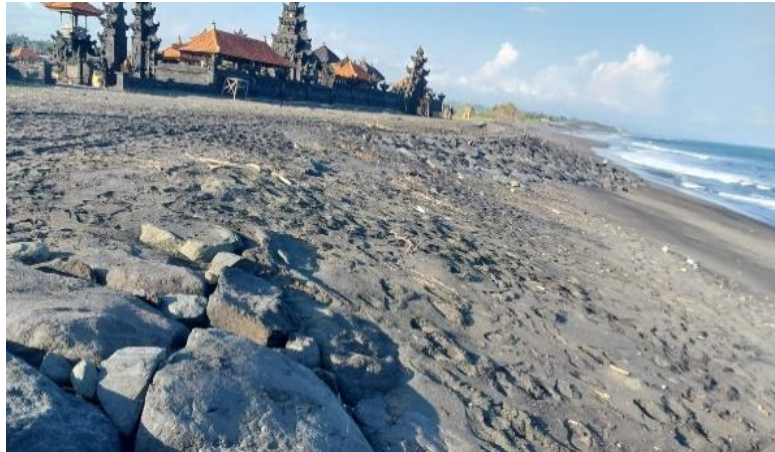
The strong wave impact is one of the factors causing the area to experience abrasion and wave overtopping [7]. Wave overtopping occurs because the wave run-up exceeds the crest elevation of the structure, meaning the crest elevation is lower than the wave run-up [8] [9]. In 2022, a tidal flood reached the temple area and the surrounding rice fields [10], causing sedimentation to cover 92 meters of the revetment. Sedimentation is the addition of land due to the deposition of sediment carried by currents [11], reducing the performance of the revetment. To address these challenges, ongoing maintenance and potentially redesigning the coastal protection structures may be necessary to ensure they can withstand the dynamic coastal environment and continue to

Figure 1. The condition of the revetment at Rangkan Beach

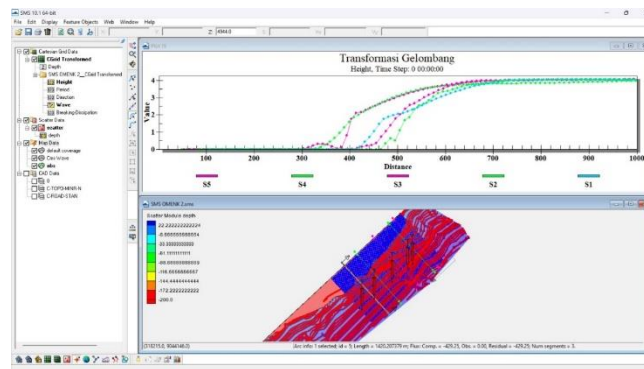
Figure 7. Wave transformation results

The results of the wave transformation in Figure 7 show the wave height at the existing revetment. This data is summarized in Table 6.

Segment	Wave Height (m)
S5	1.460
S4	1.264
S3	1.384
S2	1.685
S1	1.454
